ADVERSE WEATHER TESTS OF THE HH-53C HELICOPTER

TECHNICAL REPORT ASD-TR-70-51

DECEMBER 1970

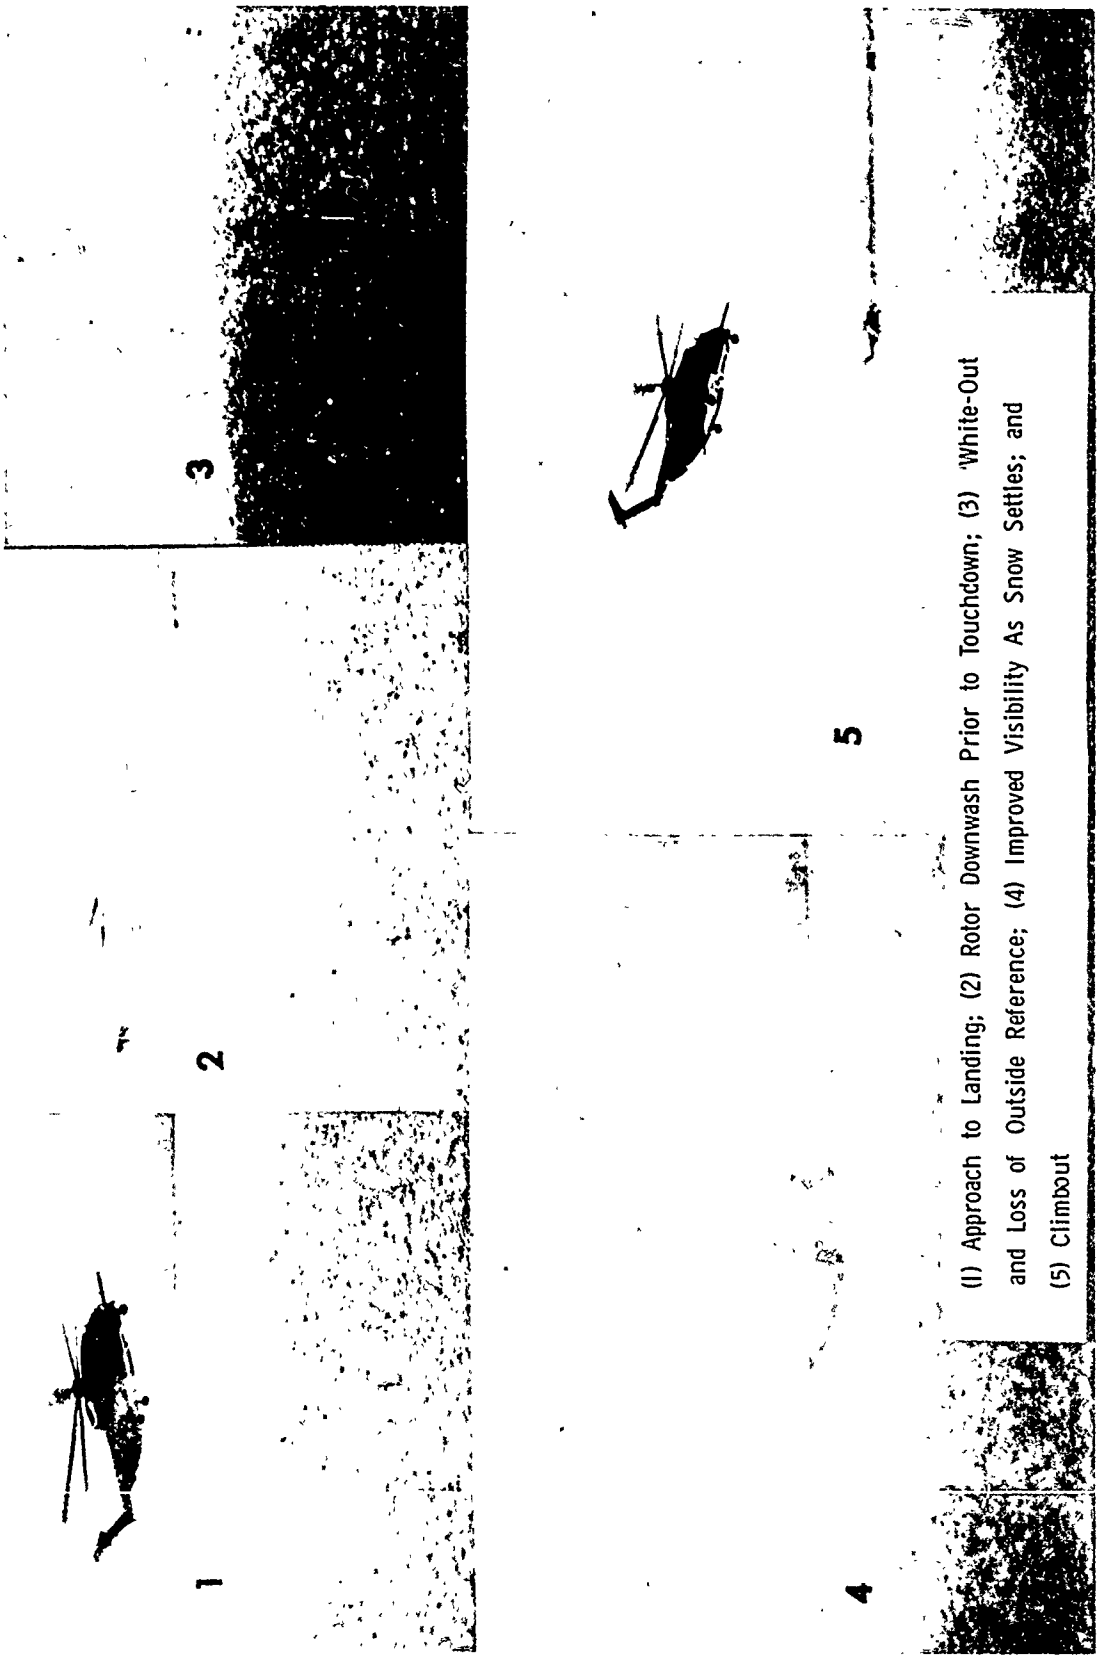
Figure 5. Typical "Whiteout" Experienced When Landing in Powdery Snow

17. As a result of the landing sequence shown in Figure 5 (Mission No. 6), the pilots and engineers adopted procedures that minimized the chances of getting completely disoriented when landing in powdery snow. It was found that when the natural horizon was totally obscured by rotor-blown snow, visibility was reduced to about 100 feet directly in front of the helicopter. Once this happened and a total whiteout was established, the pilot became dependent on objects on the ground near the intended landing zone, in addition to his attitude indicator, for visual indications of the helicopter's attitude. Taxi lights, stakes, and flares were helpful in identifying the ground during a whiteout. The only factor that prevented the pilot from aborting the landing mentioned above was his ability to distinguish small clumps of grass sticking through the snow cover directly in front of the helicopter.

(1) Approach to Landing; (2) Rotor Downwash Prior to Touchdown; (3) 'White-Out' and Loss of Outside Reference; (4) Improved Visibility As Snow Settles; and (5) Climbout

72. Land from a hover if landing on ice-covered snow. If landing in loose, powdery snow, plan to land without a hover. Expect a whiteout if the rotor wash catches up to the aircraft before touchdown.

NOTE: If a whiteout is encountered before landing, execute a go-around by maintaining a level pitch attitude while increasing collective to takeoff power.

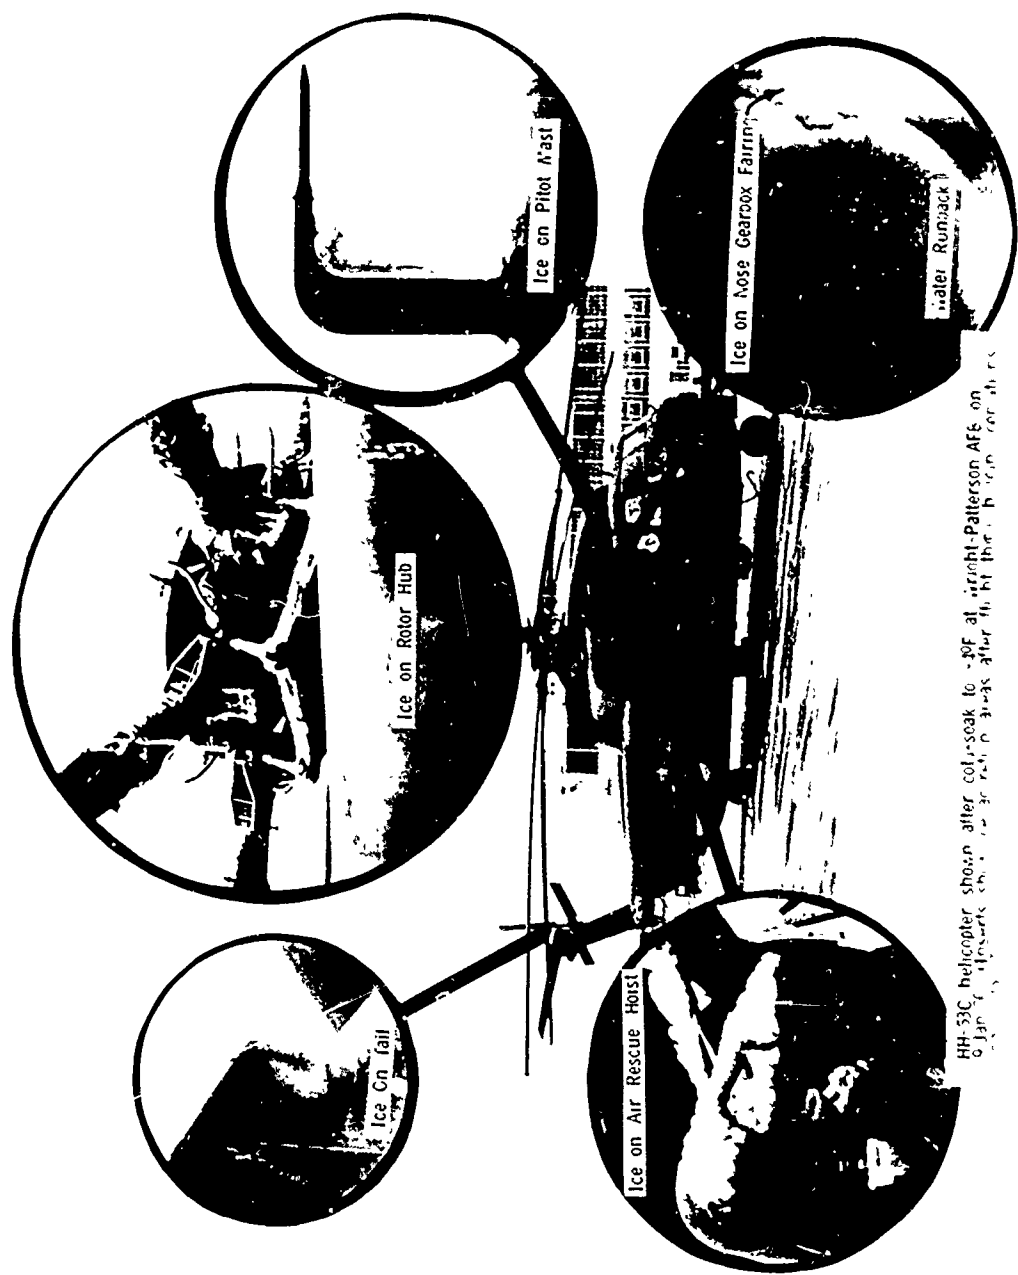
Figure 7. Composite of Helicopter Icing

a. Ice accumulated on the nose gearbox fairing, while no other part of the aircraft was observed to be accreting ice (see Figure 7 inset). This occurred twice during the flight simultaneously on both engines. At no time during the morning flight did ice accumulate on any of the heated portion of the engine inlets. Ice on the gearbox formed rapidly (in about five minutes) and was estimated to be 1/2 inch thick just prior to being ingested by the engines.

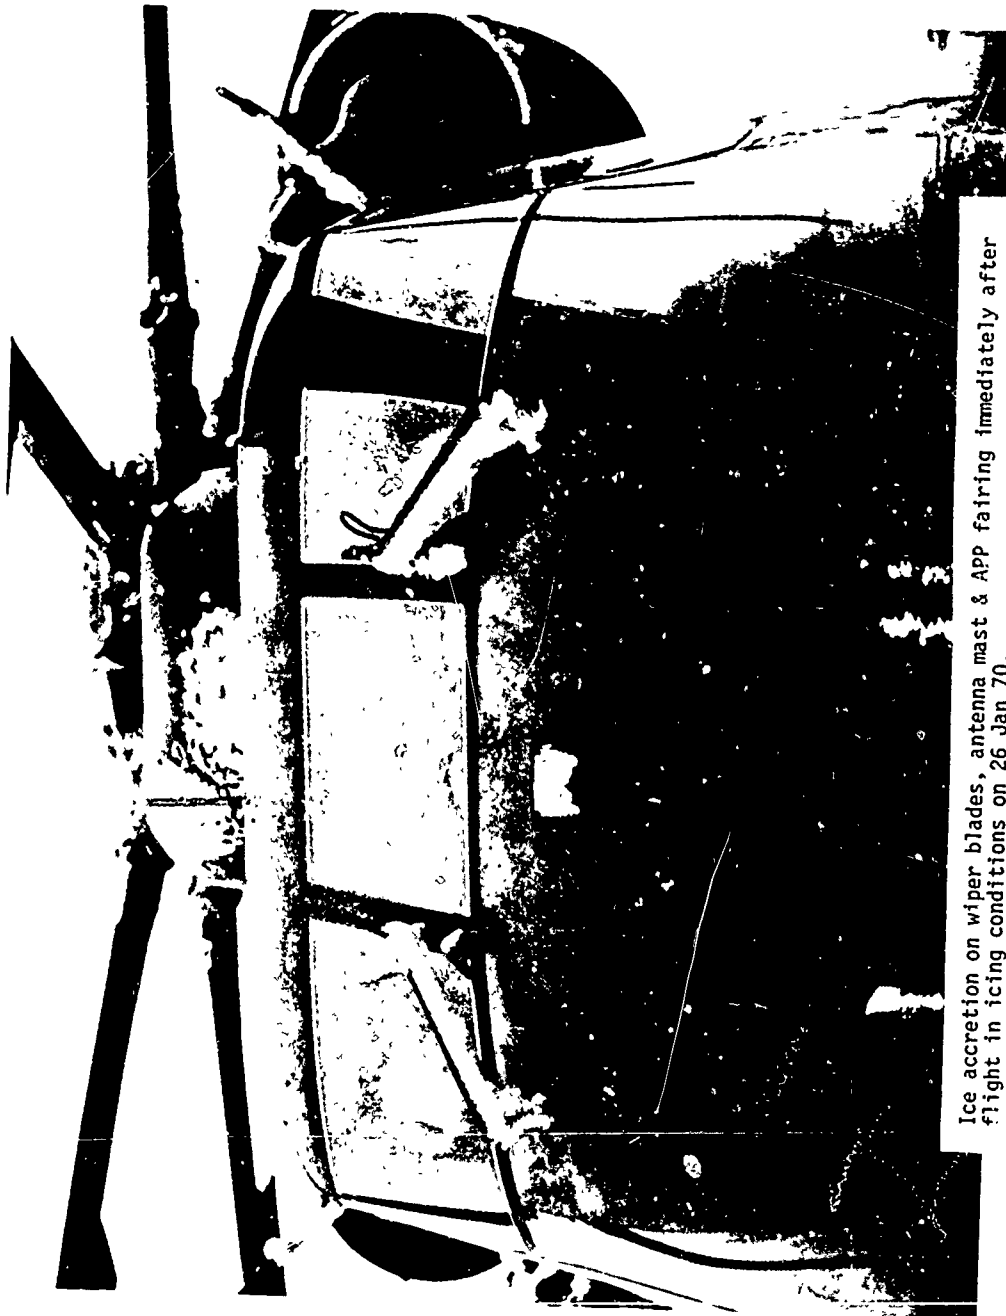
Figure 8. Ice Accretion on Front of Helicopter

Ice accretion on wiper blades, antenna mast & App fairing immediately after flight in icing conditions on 26 Jan 70.
